WALLKILL RIVER BASIN
TRIBUTARY TO WALLKILL RIVER,
SUSSEX COUNTY
NEW JERSEY

LAKE PANORAMA DAM &

LAKE PANORAMA DIKE NJ 00816 & NJ 00828

PHASE 1 INSPECTION REPORT
NATIONAL DAM SAFETY PROGRAM

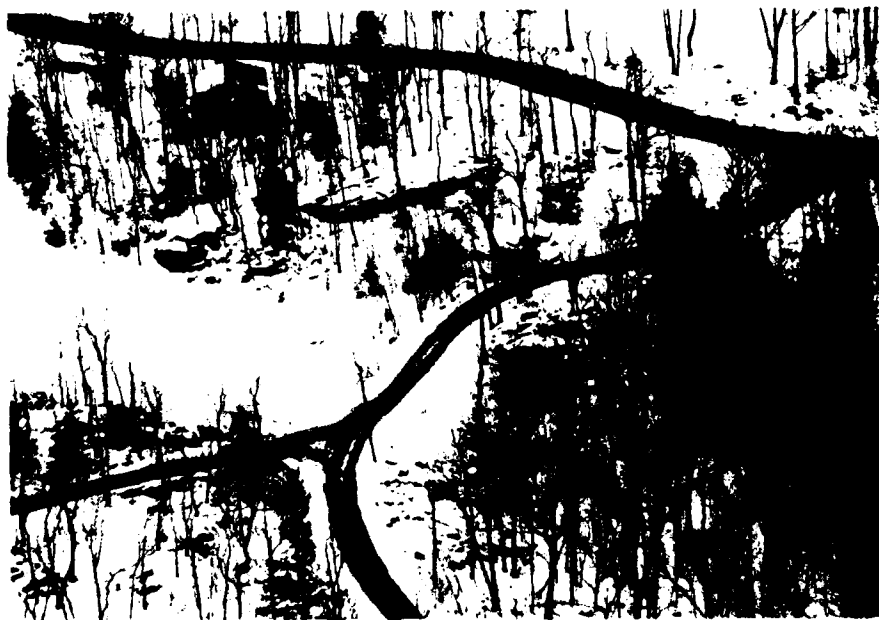
PHOTO 2

CREST OF DIKE WITH DOWNSTREAM FACE TO
THE RIGHT AND LAKE TO THE LEFT
